# Quality *focus*

*A Quarterly Publication of the Ohio School Facilities Commission For Architects, Engineers and Construction Managers who Participate in OSFC-funded projects*

## Alternative Dispute Resolution Involving a Neutral Third-Party

## Product Spotlight – Spray Foam Roof Systems

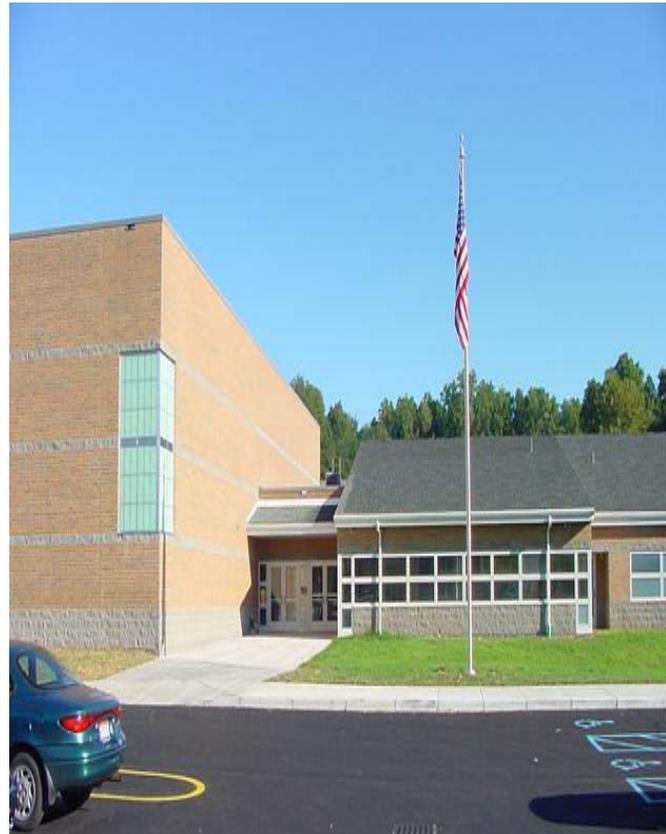
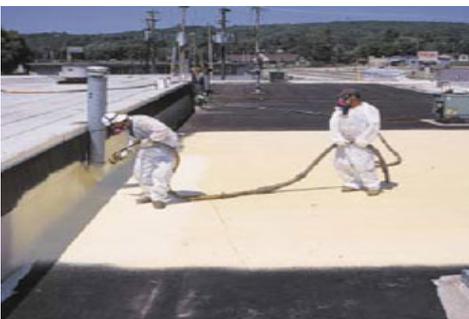
*Frontier Local Schools, Newport Elementary/Middle School Washington County, Ohio*

In May 2005, a consultant was hired by the Ohio School Facilities Commission (OSFC) to determine the cause of chronic water intrusion conditions at Frontier Local School District. To maintain continued support of the original project team, each party was called upon to respond to the concerns of the co-owners. The original Contractor and Project Architect were in disagreement on some of the construction issues, and as a result the Contractor refused to participate in providing a solution. The balance of the project team remained intact and the owners dealt directly with the contractor's Surety.
