# Quality *focus*

A Quarterly Publication of the Ohio School Facilities Commission  
For Architects, Engineers and Construction Managers who participate in  
OSFC-funded projects

## How to Resolve Difficult Post-Construction Issues (w/o Litigation)

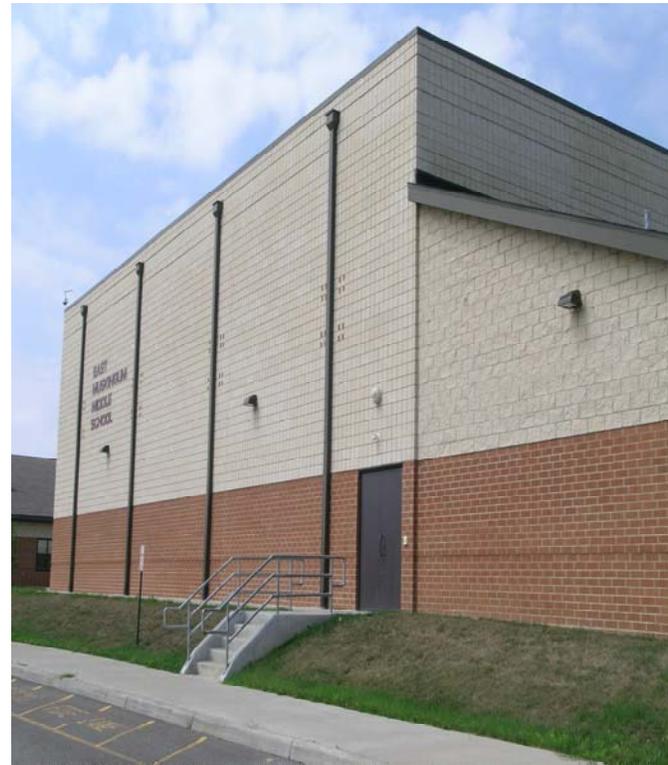
East Muskingum Middle School  
Muskingum County, Ohio

OSFC conducted an investigative evaluation program of the leakage problems at the East Muskingum Local School District Middle School. The leaks were recreated by spraying water directly onto areas of the concrete masonry unit veneer. The investigation indicated that there were problems with the wall flashing and the wrong counterflashing was installed. Based on findings of the comprehensive investigative program, the development of specific repair recommendations was required. Triad Architects, Ltd. and Davis Architectural Group, the architects of record, issued

remedial drawings for the project. In addition, construction management services were provided by Project and Construction Services under their original contract. Grae-Con Construction, Inc., the general trades contractor, performed the remedial work required under the revised plans. This project was successful because the project team remained intact and worked together with the school district and OSFC throughout the process. A settlement was reached by all parties and the school district is enjoying a leak-free building thanks to the efforts of all involved.
