# Quality *focus*

A Quarterly Publication of the Ohio School Facilities Commission  
For Architects, Engineers and Construction Managers who  
Participate in OSFC-funded projects

## When a Lawsuit Gets Filed Against All Parties

# Gym Floors – How Does Your Ball Bounce?

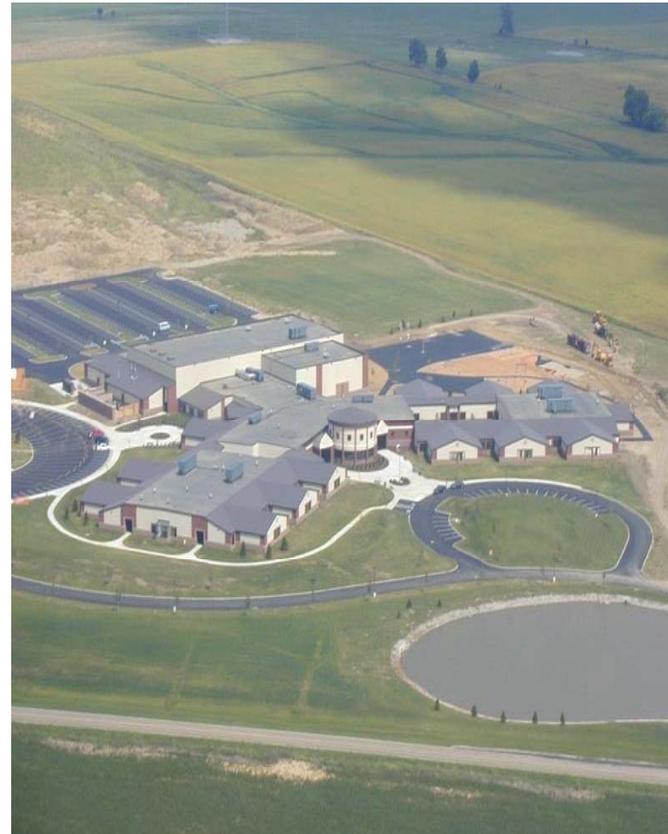
Adena Local K-12 School (Aerial Photo)  
Ross County, Ohio

An investigation of water leakage into the Adena Local Schools K-12 facility was conducted in June of 2006. The structure is a single-story building with two types of roofing systems. The flat roof sections are a mechanically fastened EPDM membrane while the sloped roof areas consist of metal shingles. Through a detailed evaluation, the consultant determined that the main source of water leakage was in the field of the metal shingles. Given that these shingles are a water-shedding system, not a water-tight system, a significant amount of the leakage was caused by the

overwhelming amount of water that flowed over them at such a low slope (3/12). In order to mitigate the risk of future failures, a lawsuit was filed by the owners against multiple parties. An agreement was reached that outlined roofing repairs that addressed the consultant's recommendations. Should the roof fail of its essential purpose, then the identified responsible party is required to fund a roof replacement. To date, the repairs seem to be working. A final water leak test occurred last month to determine if the repairs were successful. The results of this test are pending.
